## Smoke and Dye-Water Observation Summary

### Western Run Pilot Project - Baltimore Maryland

## INSPECTION REPORT

STREET: CLOVER RD. TEST 86 A1	MAP #1: 1	MH: 1521179
CITY: BALTIMORE	MAP #2:	MH: 1521346
LOCALE: MAIN RESIDENTIAL STREET	TAPE #: JAM 2	TV'D LGTH: 180 ft

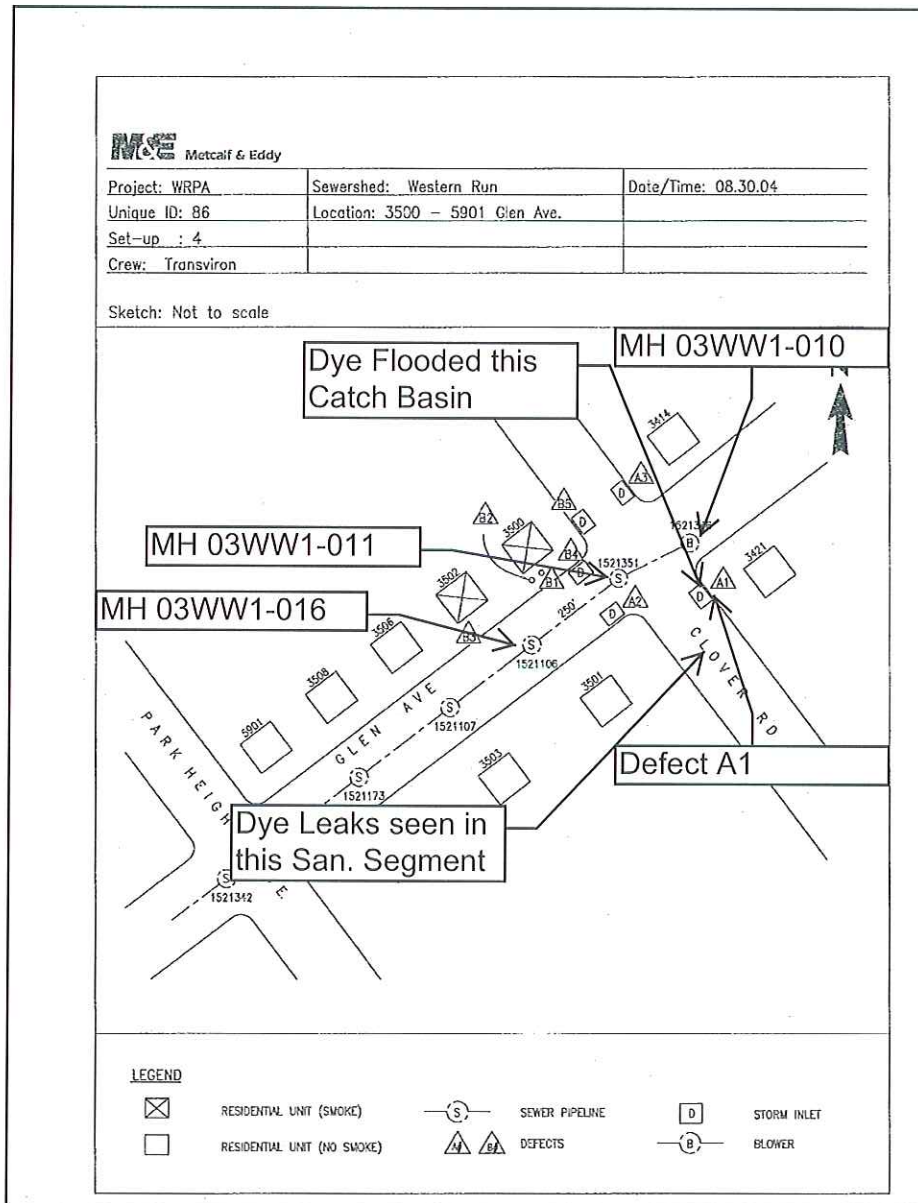
Sketch No: 86

Additional Comments: THIS FLOODING (PLUG) HELD VERY WELL. THE C.B. RECEDED VERY SLOW. THE LEAK(S) ARE BE VERY SMALL. ONE SM. JOINT LEAK SEEN. (155' FROM 1521179 TO C.B. AREA.)

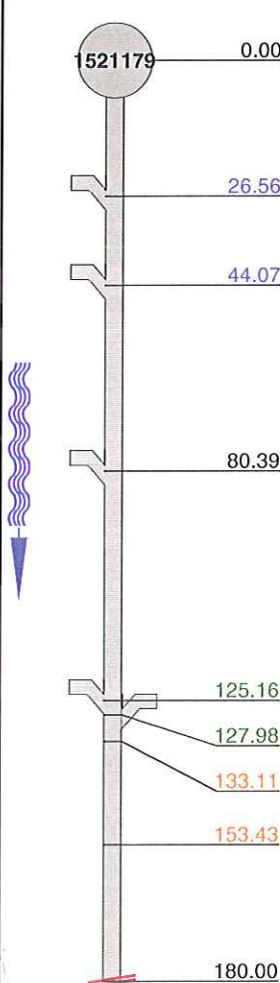
0.00	inspection begins at upstream manhole. 1521179	0	00:21:23	
	26.56	service connection with roots medium at 03 o'clock	2	00:23:06	17a
	44.07	service connection with roots medium at 03 o'clock	2	00:24:12	18a
	80.39	service connection capped at 03 o'clock	0	00:25:54	
	125.16	break-in-connection at 03 o'clock	1	00:28:17	
	127.98	break-in-connection at 09 o'clock	1	00:28:40	
	133.11	Circumferential Fracture from 12 to 12 o'clock	3	00:29:36	22a
	153.43	Infiltration Running at joint at 08 o'clock, VERY HARD TO SEE camera lens dirty and leak is small		00:36:28	
	180.00	camera blocked, inspection abandoned, TOO MUCH DEBRIS	0	00:35:49	23a
